The McGill Farmhouse is a common house type for the mid-Atlantic region with its central entrance, symmetrical main facade, and ell rear wing. Cecil County tax records show a new house on the McGill property around 1861.

INVENTORY FORM FOR STATE HISTORIC SITES SURVEY

BLYTHEWOOD FARMS

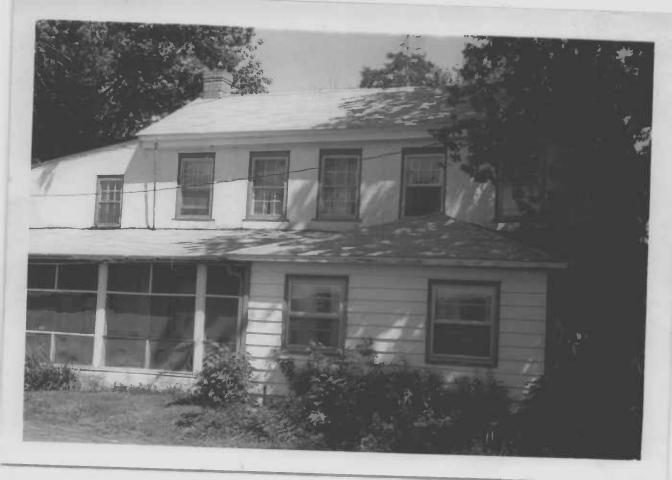
Megill - CARPENTER House SOUTHERN ELEVATION NR CHARDON EARLEVILLE, MP. P31 6/79

The southeast (main) facade is typically symmetrical with a central entrance and flanking six-over-six sash with plain trim. A boxed cornice with applied molding stretches across above the second floor sash. The first floor is covered with a screened-in porch on the western two bays. The eastern three have been covered with a two bay hipped roof addition of fairly recent date.

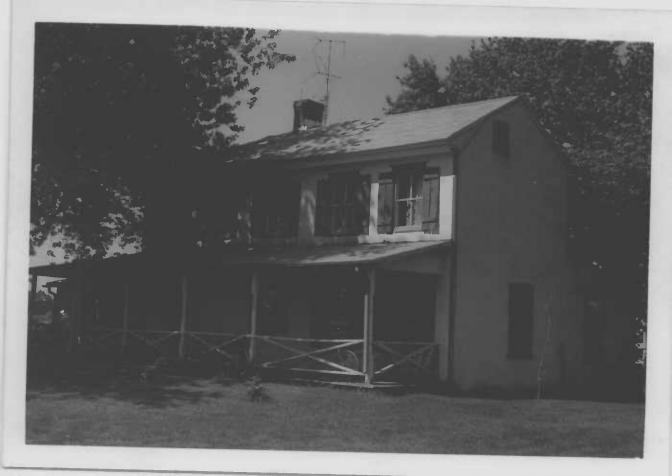
EAST ELEVATION

The eastern side is four bays across with an entrance in the southern most bay. The sash is two-over-two with mid 19th Century shutters. (Two boards with batten.) A shed porch extends across the bays and is supported by turned posts. The ends are decorated with a saw-tooth vertical board. The cornice is the same as the front of the house. The east side of the main block does not have a full gable end. The roof of the ell wing continues to the southeast corner of the main block which gives the house a ell shape. A stove stack rises out of the south section of the ell addition. There is no visible stack in the gable end, espically since a two-over-two sash is located in the center of the first floor wall. A small four pane light illuminates the attic.

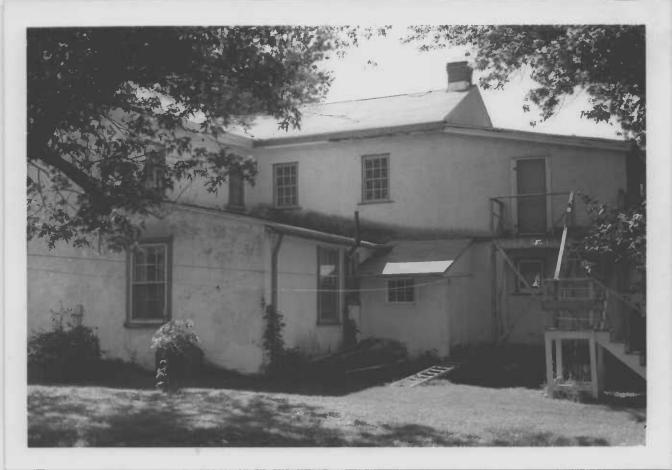
Me GILL - CARPENTEN HOUSE CE-933
WEST ELEVATION
NR
EARLEVILLE, MD.
PBT 4/79

The west end of the main block is covered with two story shed addition with six-over-six sash also. A wooden fire escape is found on the northern side of the shed roof addition. A brick stove stack does rise out of the main gable.

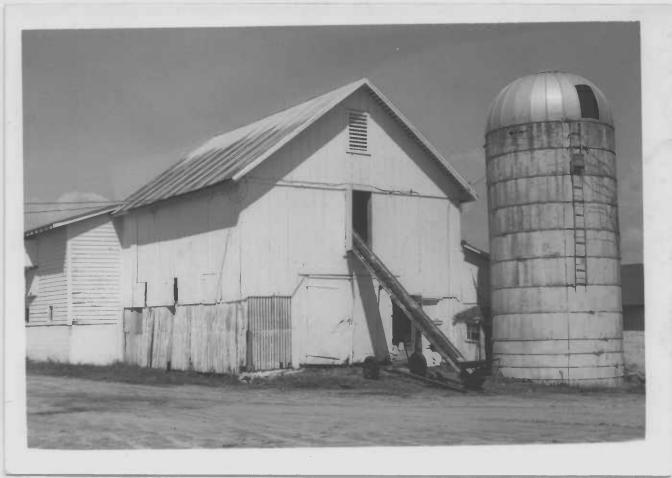
MEGICC CARPENTER House CE-933
EAST ELEVATION OF GRANAMY
NR

The interior has been fairly well remodeled in the 20th Century. The only significant mid 19th Century barn building is a two story frame granary with vertical board sheathing. A central passage is flanked by single story ventilated corn bins. Recent additions extend from the west and north sides.
